## Results from samples extracted during SPS shutdown

Diagnostics of the apparent disagreement between the SPS data on coated dipoles and the e-cloud suppression in coated monitors:

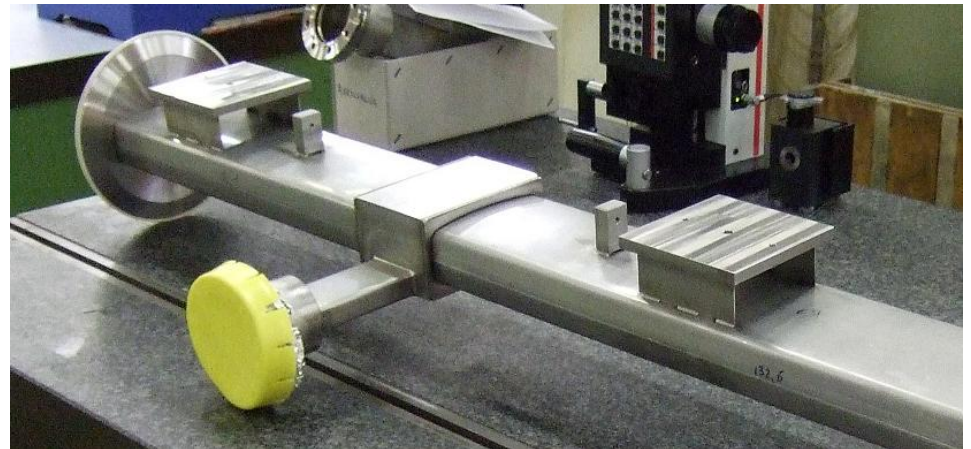
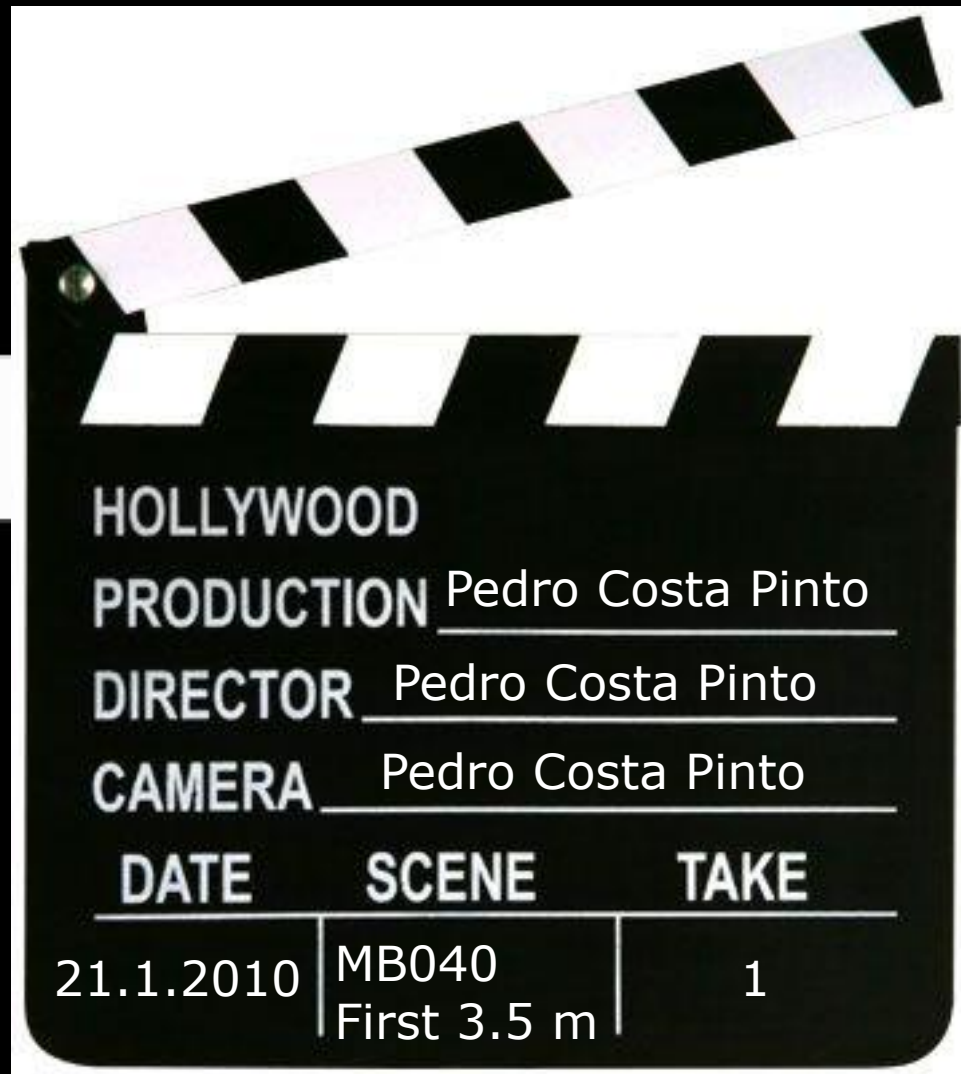
## endoscopy of the magnets

Various defects and spots visible, but no easy conclusion

-→ cut open the magnet chamber (not yet)

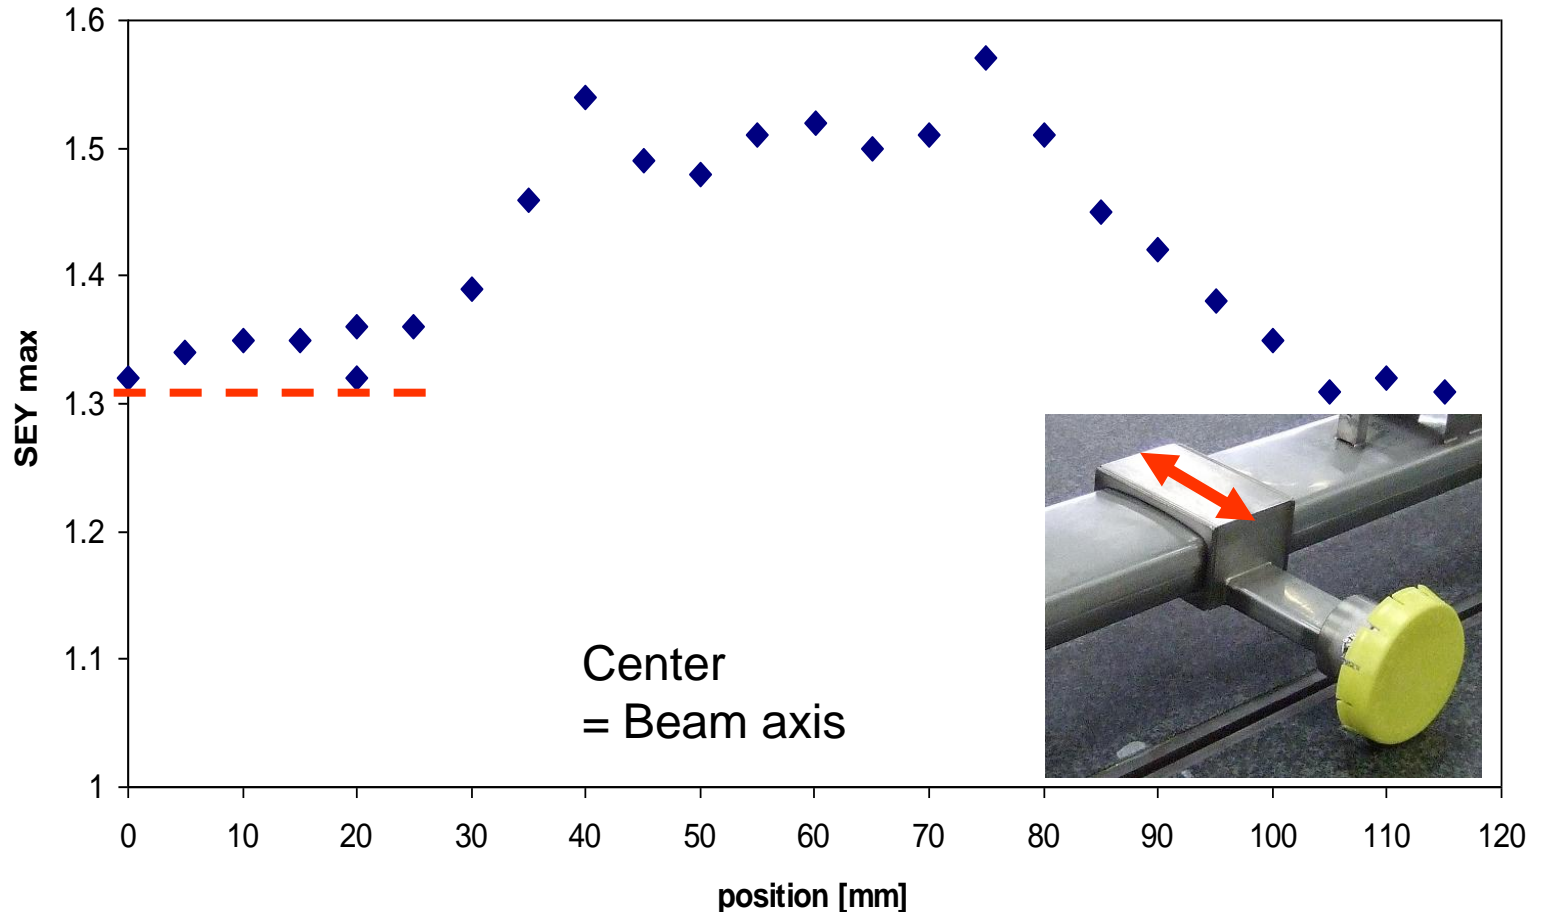
## SEY along the sample

Sample coated with MBB dipole and stored in pumping port of dipole

- The central part has experienced e-cloud, since the opposite wall is made of stainless steel, without coating
- Aging up to 1.55 at the center is related to irradiation
  - Aging from 1.1 (initial value) to 1.3 on the edge is related possibly to the residual gas only. As for samples in the MBB pumping port

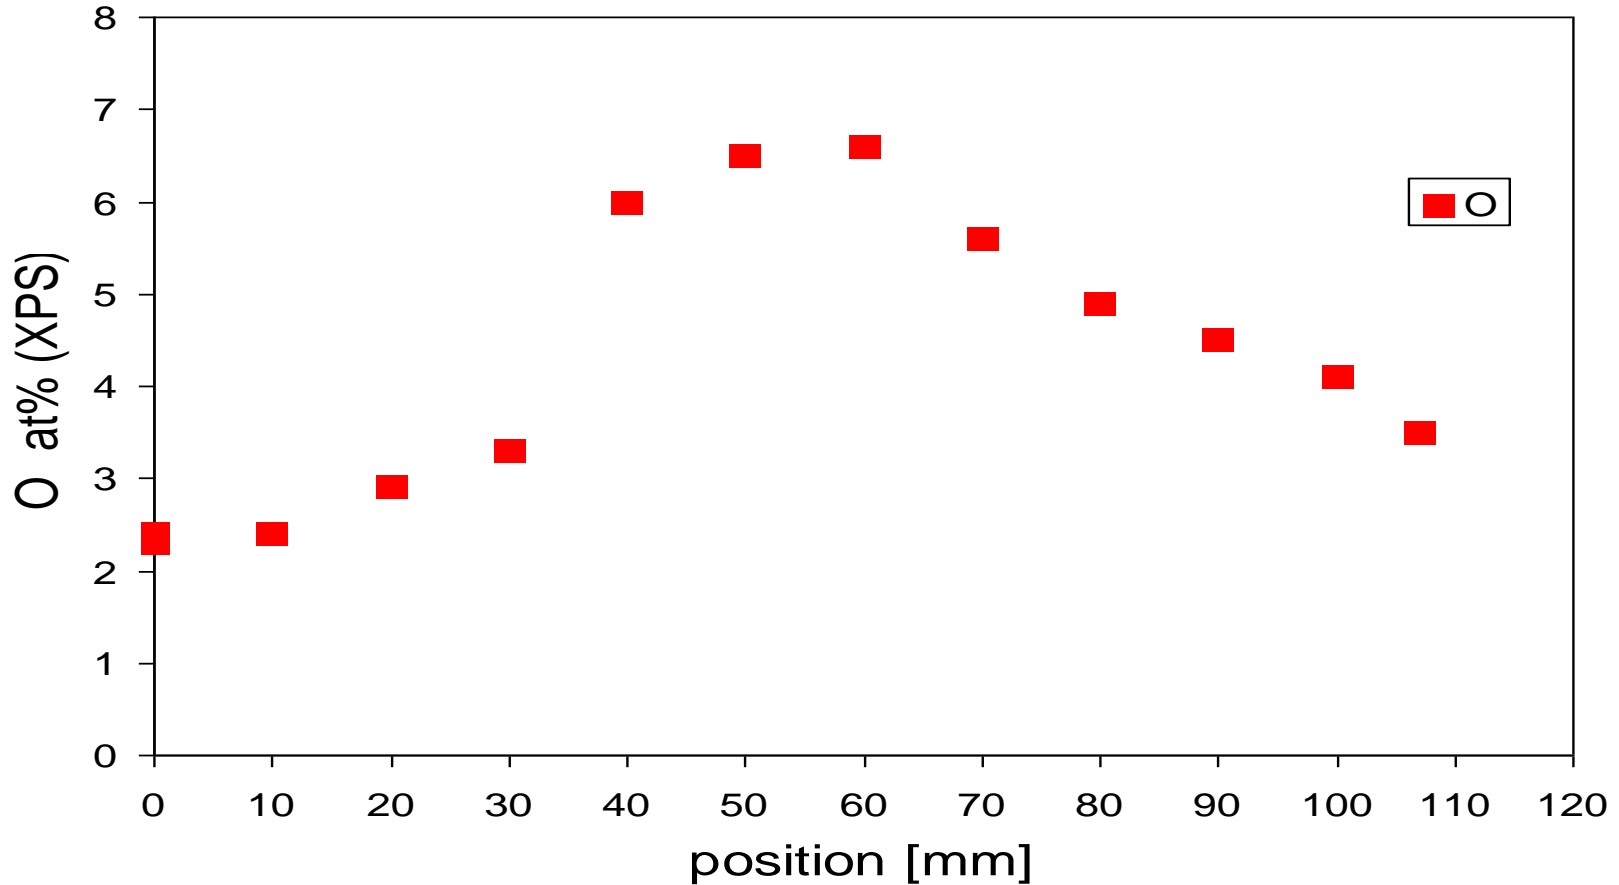
## Surface analysis: oxygen concentration

The central part of the plate has a higher oxygen concentration

→ the irradiation induces **reactivity of the surface, either to the residual gas (unbaked) or to the venting gas**

→ the amount of oxygen is still very low compared to other coatings with lower SEY

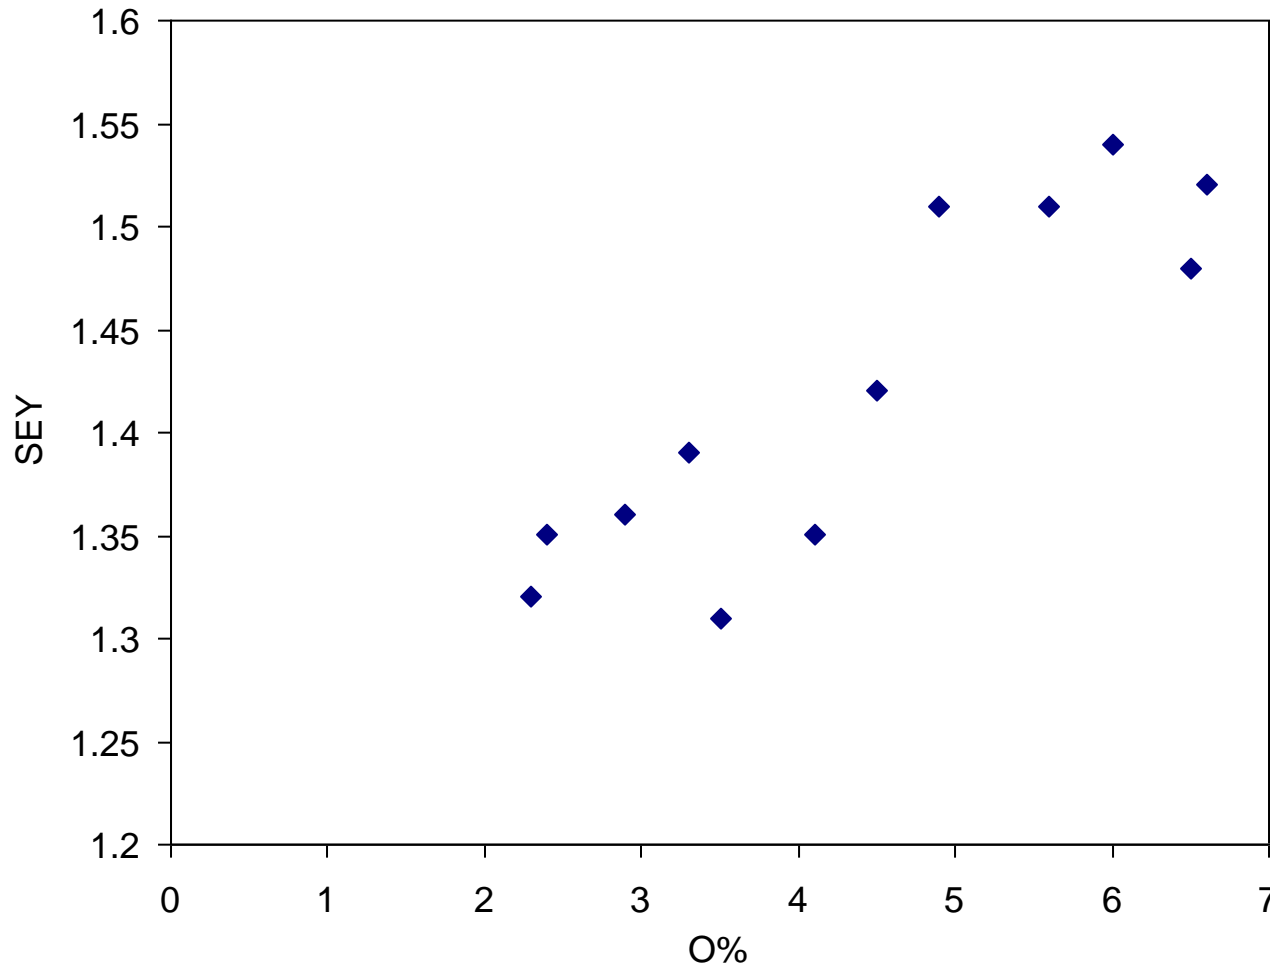
The presence of O correlates well with the SEY increase: **is it O from O<sub>2</sub>, H<sub>2</sub>O or hydrocarbons? Is it the source of the problem?**

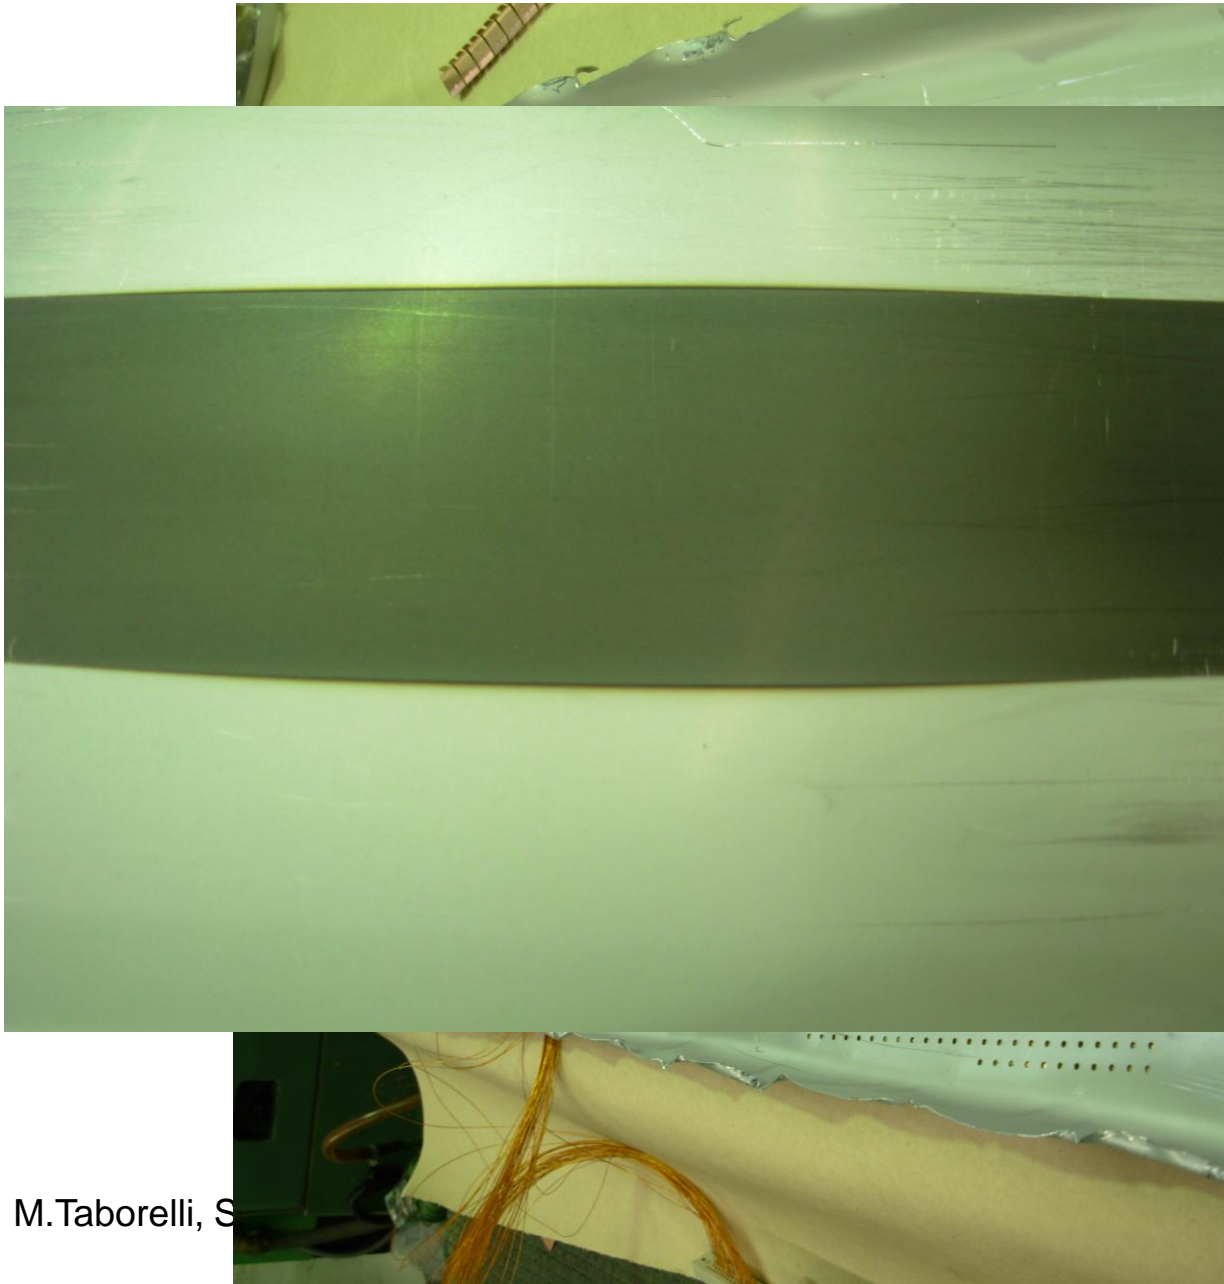
## Samples from liner in e-cloud monitor:

Stripe liner inserted in  
SPS from March 2009 to  
February 2010

Cut open 15/2/2010

Coating is uniform  
(visual inspection)

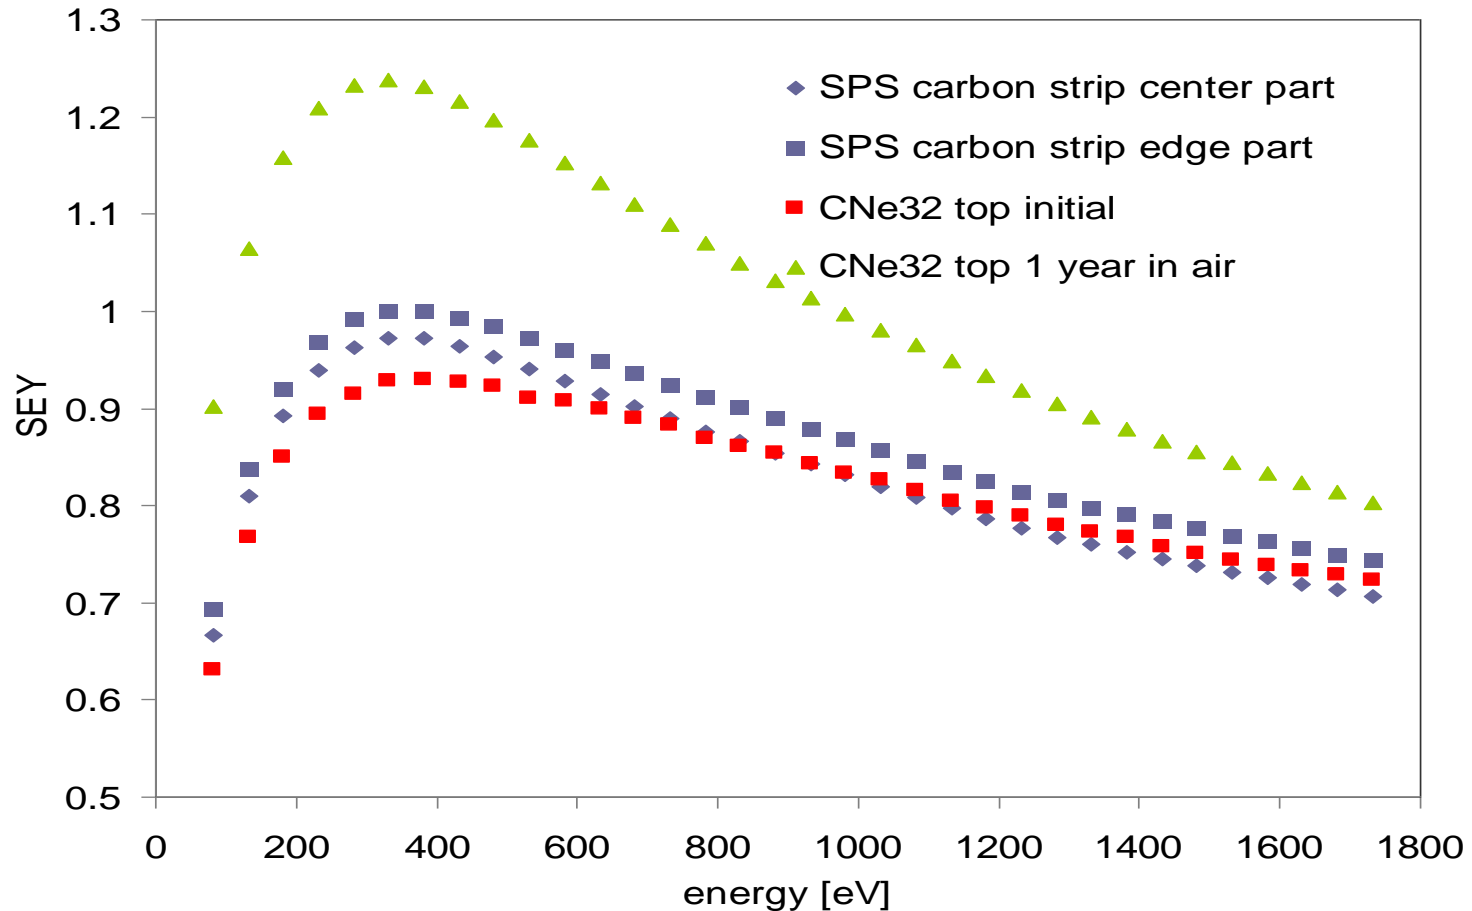
# SEY of a sample cut from liner

History: the liner was 1 year in SPS + 1 month in air

-Aging is very weak

-Aging in air for the witness sample is faster

-NB: the witness samples from the MBB1# MBB#2 coating was at 1.21 and 1.23 after only one month air (1.16 after one week)

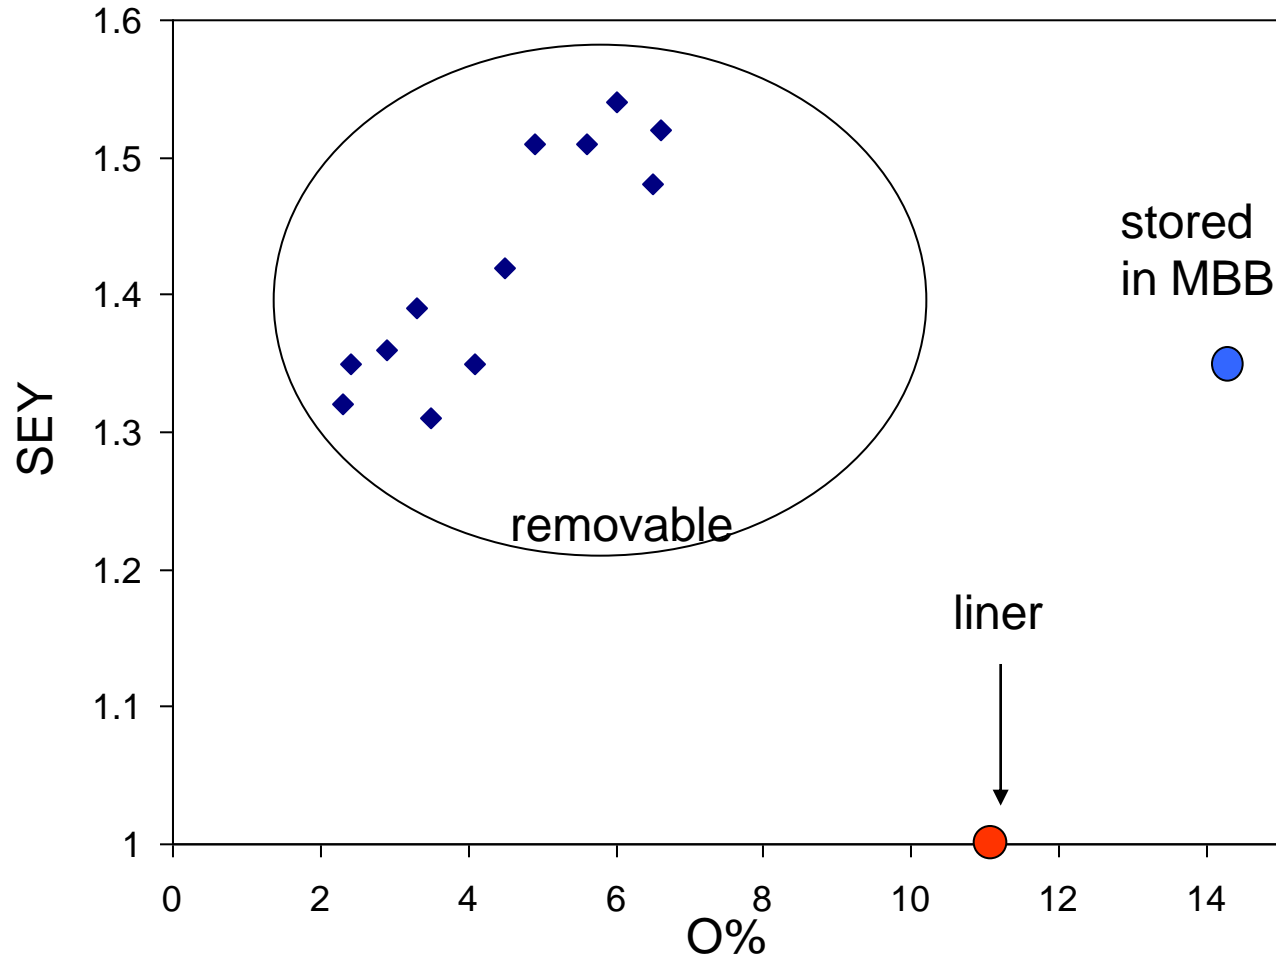
## Comparison of samples in the SPS

The correlation with the oxygen amount obviously does **not** work like this!

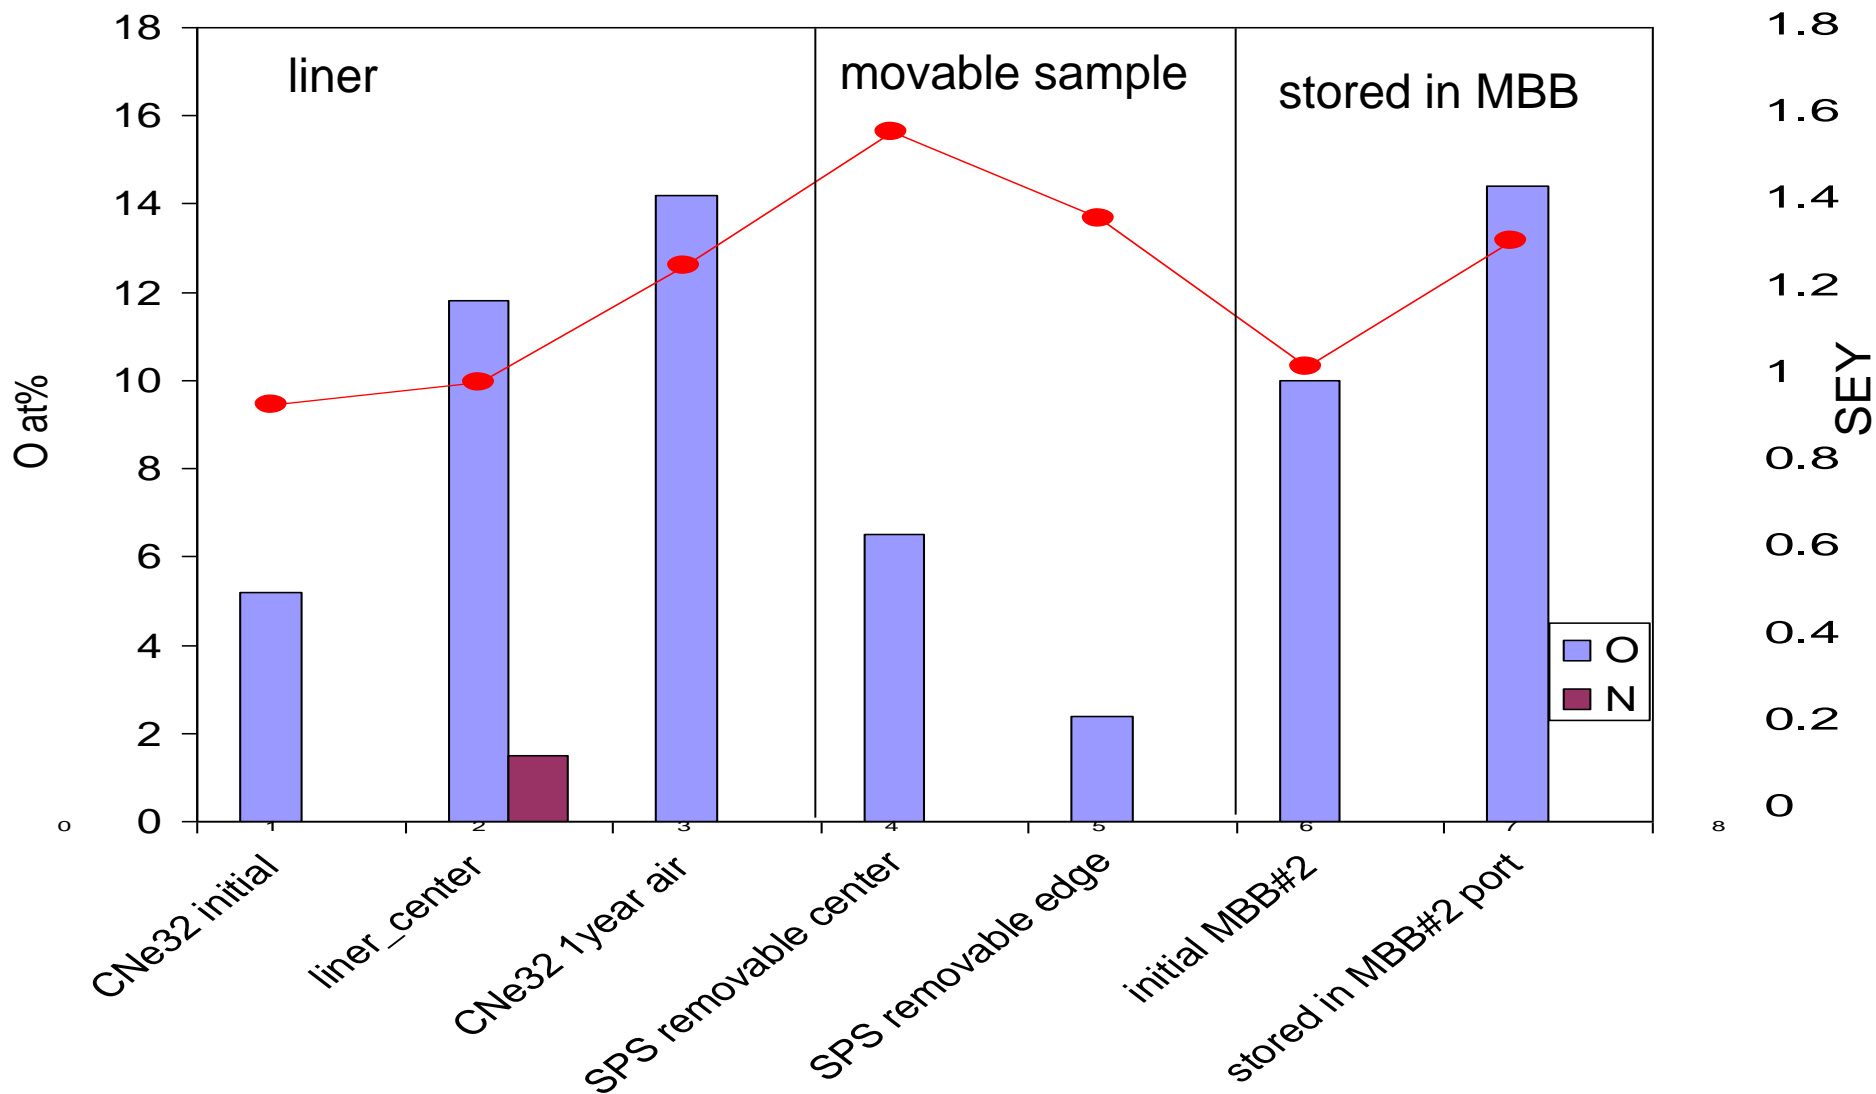
The oxygen amount correlates with SEY if we take a single sample  
**Is O the cause of the aging or is just increasing in parallel any time we have aging?**

The liner sample is the only one having N after irradiation and venting

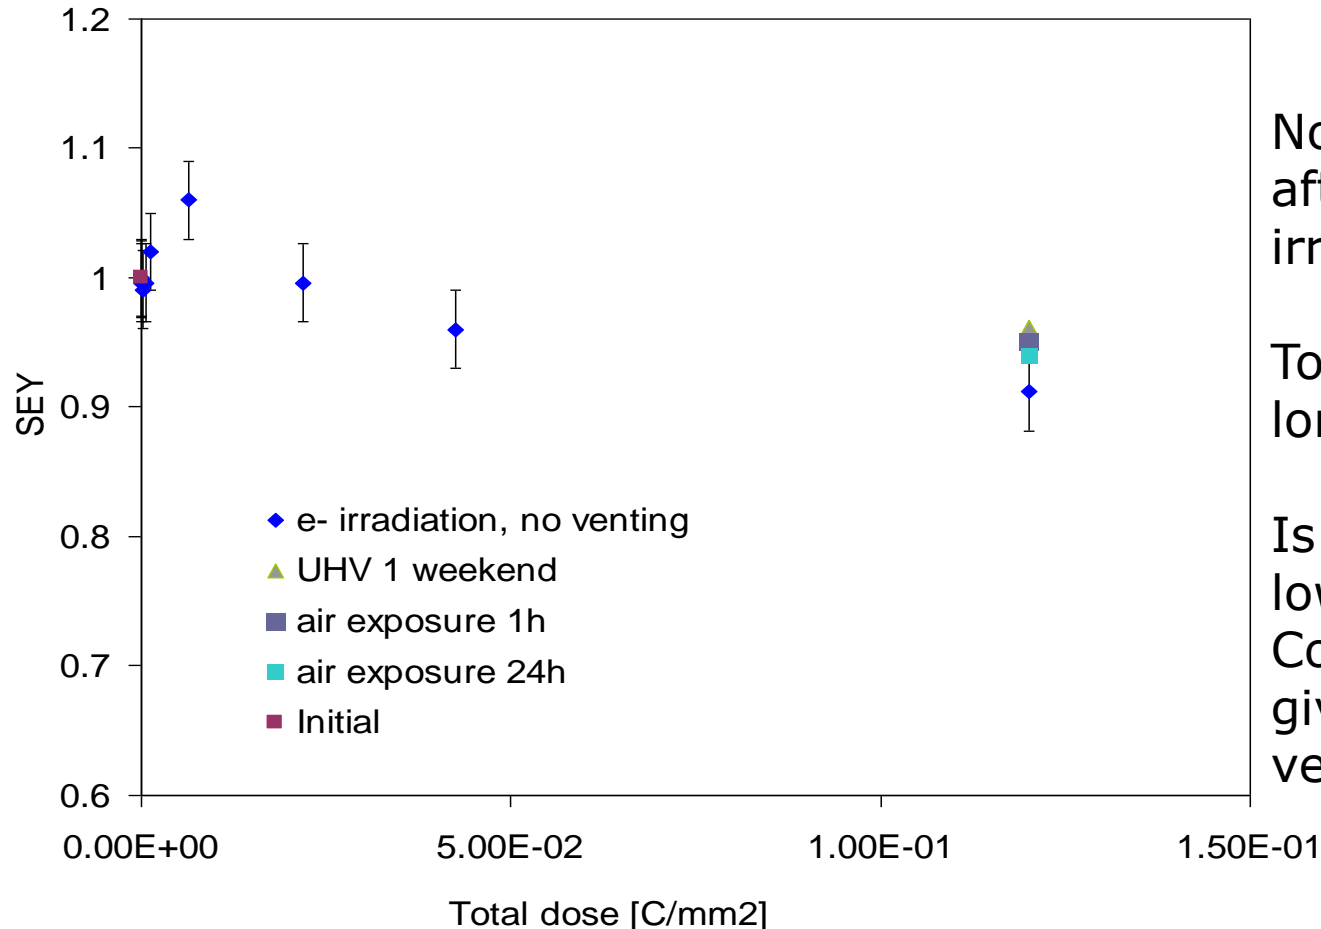
## Irradiation in the lab of the liner sample

Irradiation with 500eV electrons to reproduce what happens in the SPS  
In a baked system in  $10E-10$  mbar range

No deterioration  
after large dose of  
irradiation+ venting

To be tested for  
longer times

Is the increase at  
low doses real?  
Could a low dose  
give sensitivity to  
venting?

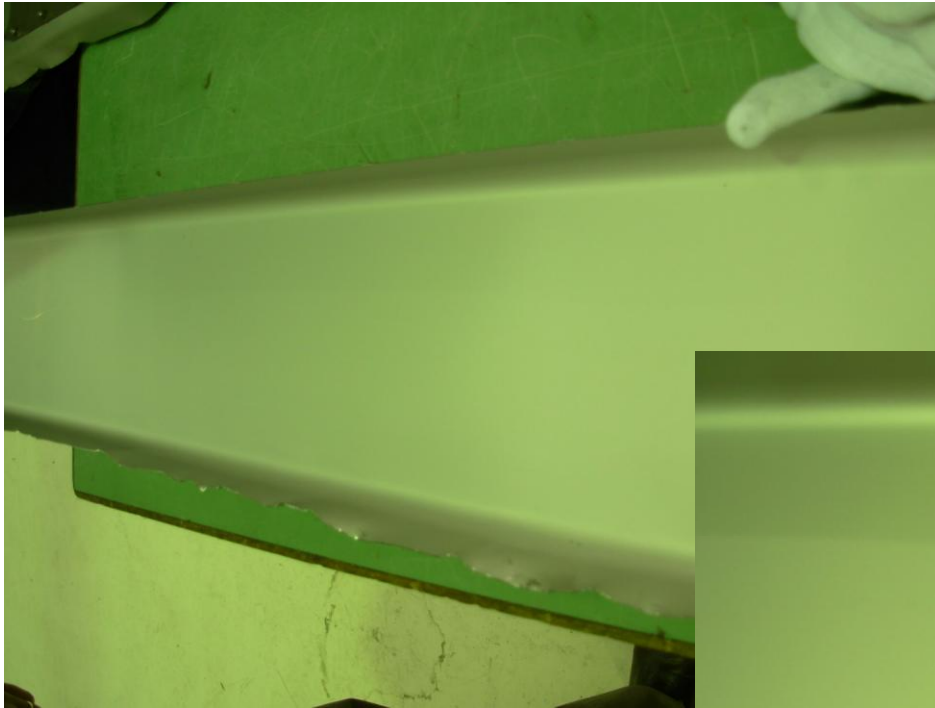
## Extracted stainless steel (StSt4)

StSt liner inserted in  
SPS from March 2009  
to February 2010

Uniform, no visible traces  
of conditioning

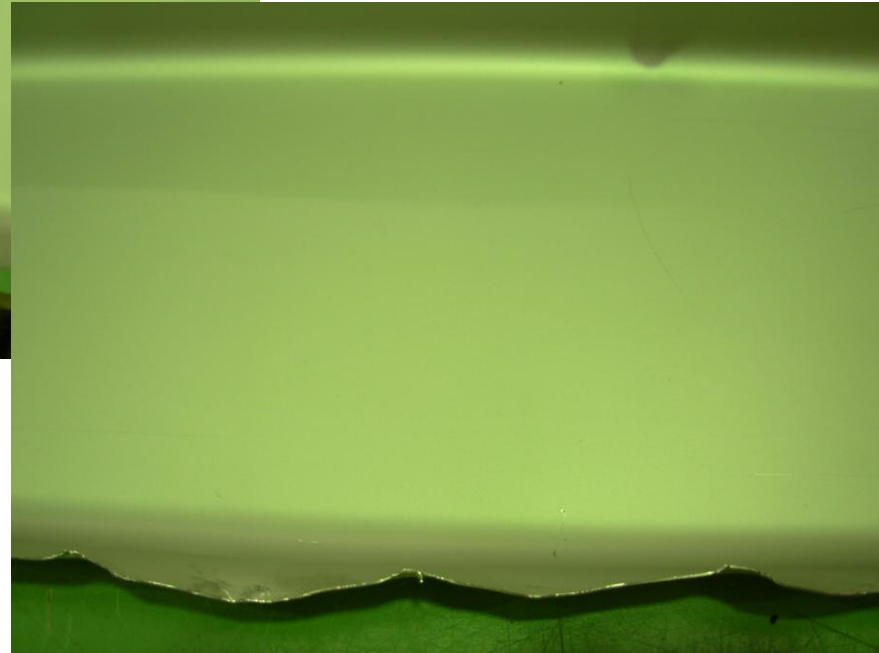
- XPS does not show strong amount of C as it is usual for irradiated samples
- SEY is 1.7-1.9, not conditioned (but they were air exposed for one week)

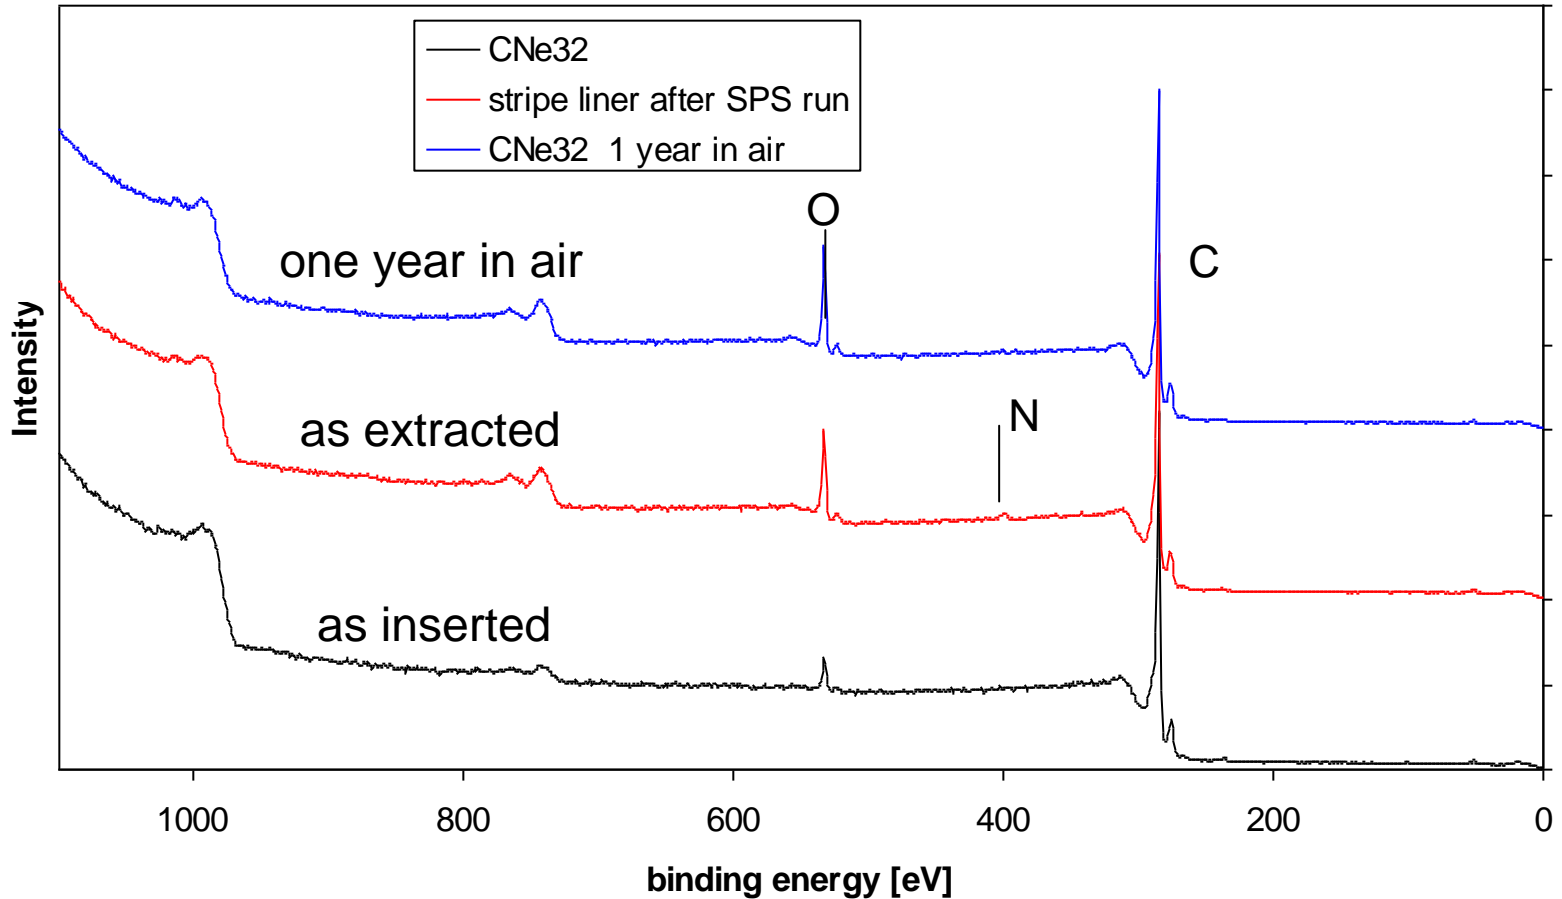
# Evolution of surface composition for liner sample

O increases and also a trace of N is visible  
The sample aged in air has even more O
