Observations during MD of June 2nd to June 3rd, 2010 and Future Plans for SPS Kickers

SPS Kicker Summary

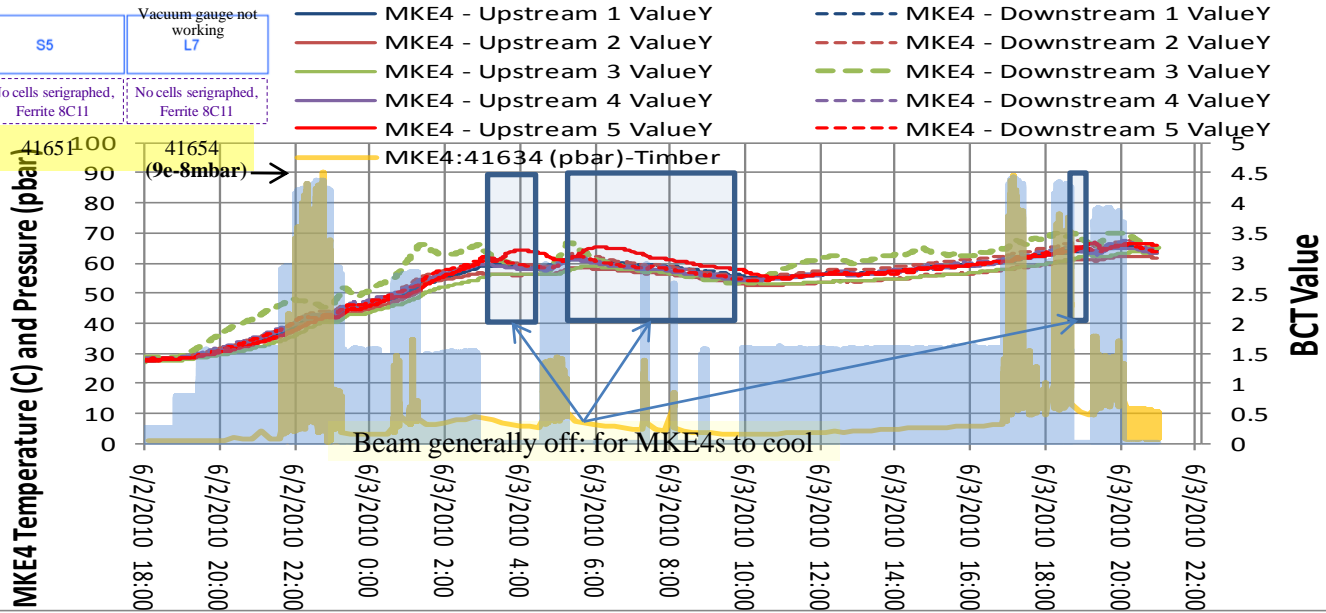
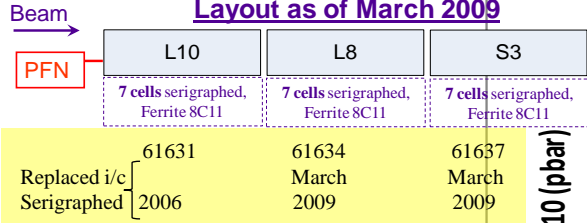
Pressure in MKE4 41634 (maximum of 9.1×10^{-8} mbar) is an order of magnitude less than in MKE6.

- **MKE4:** Shorten period of installation of 5 serigraphed MKE4 kicker magnets, from 3 to 2 shutdowns:
 - During 1st shutdown (end 2010, start 2011) replace one S-type & one L-type magnet;

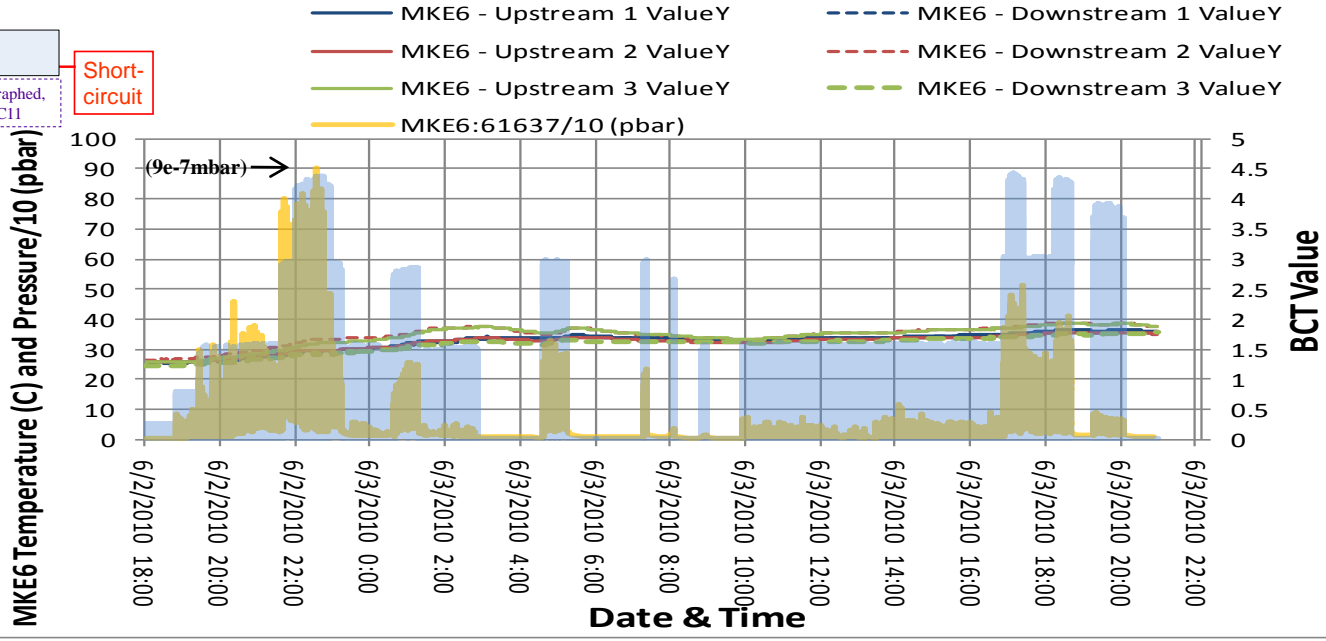
High pressure in MKE6 (9×10^{-7} mbar in 61637) – as per week 17 MD. Note: 3 serigraphed magnets. Pressure rise is an order of magnitude more than MKE4:

- Out-gassing of silver paint (serigraphy)?;
- Electron cloud? (Mauro to measure SEY).

- **MKE6**
 - Ion pump in VPIB_61635 now OK (as of 24/06/2010);
 - Measure SEY for silver paint and ferrite (Mauro);
 - Measure out-gassing of silver paint when it is warmed up slightly;

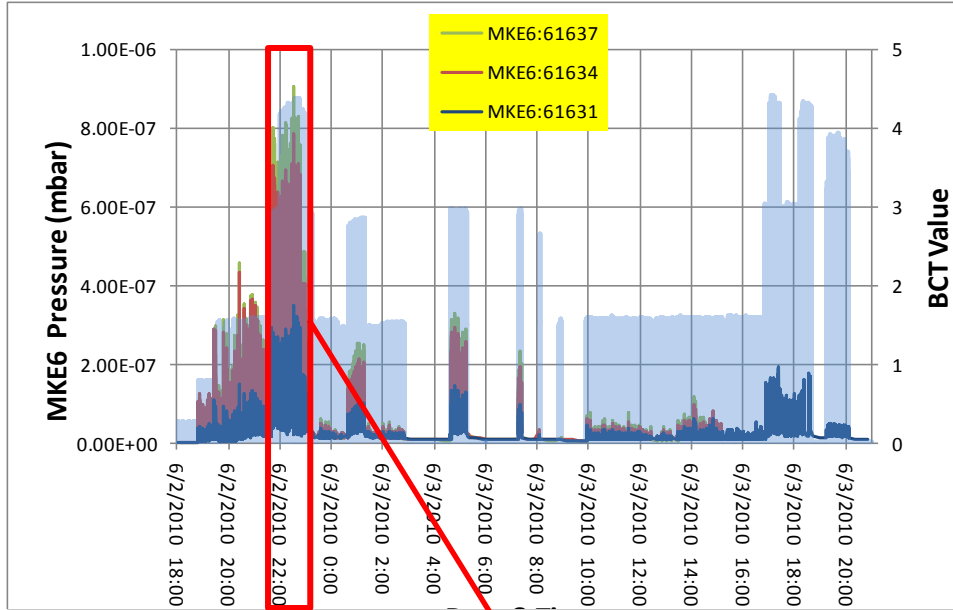
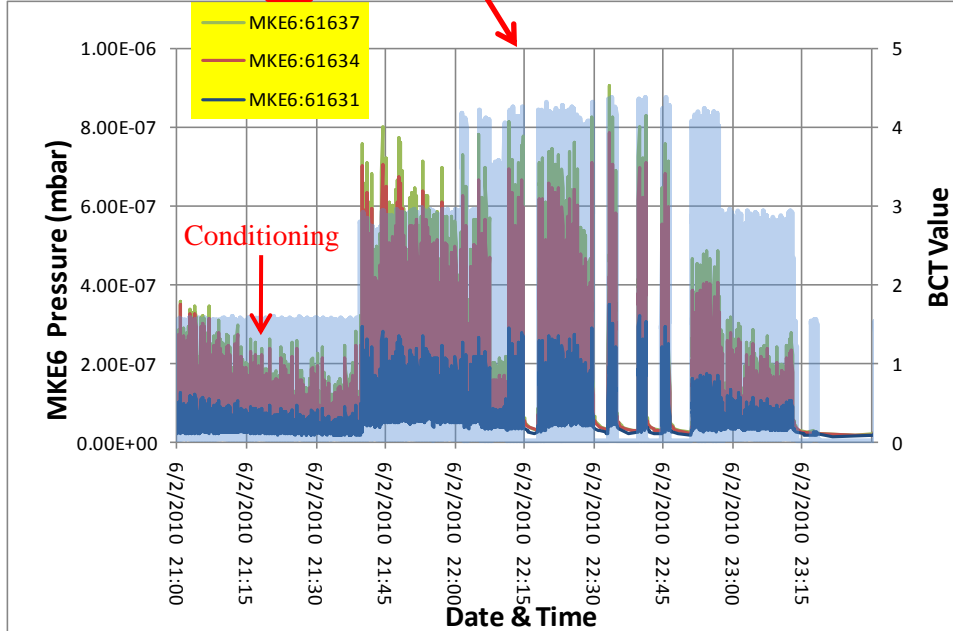
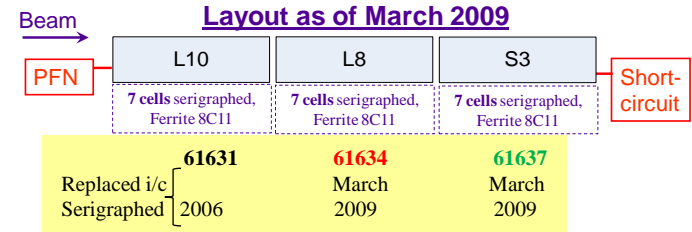
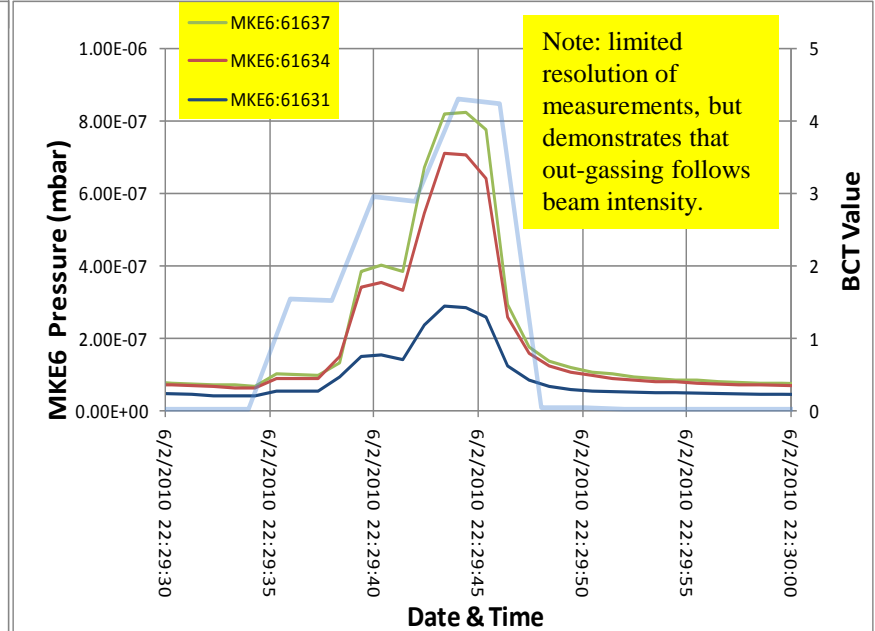
MKE6: Vacuum

- Magnets appear to condition during MD;
- Lowest pressure rise associated with kicker installed for longest period (61631). Not able to determine if “61631” out-gassing has reduced with time (61634 was previously 4E2 ferrite, with high out-gassing rate);
- Ion pump VPIB_61635 went to “Not valid state” after this MD – maybe caused by high out-gassing?. To be investigated, by vacuum group, during short technical stop (today). **Hot off the press: pump now OK.**

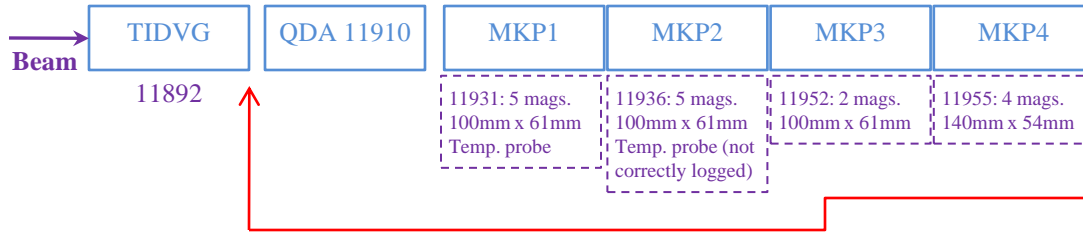
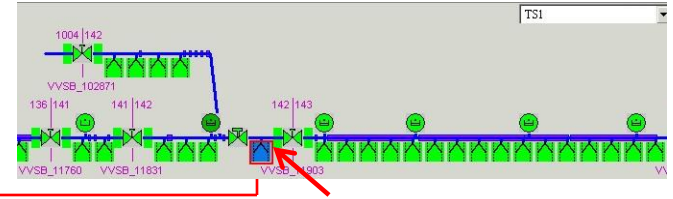
MKP: Vacuum

Pump (VPCIB_11902) close to TIDVG (11892) in “Not Valid” state, and has been for some time (not interlocked?): needs investigating.

- Transverse impedance to be measured, in clean room, for non-serigraphed and serigraphed magnet (for 2nd spare magnet being prepared).
- **MKP**
 - Pump VPCIB_11902 (close to TIDVG and MKP1) MAY need replacing. Vacuum group has been asked to check pump at earliest opportunity [out-gassing from TIDVG is NOT good for MKPs!];
