SPS-U meeting 2009-03-24

Coating of the three dipoles

SPS dipole prototype coatings Modifications

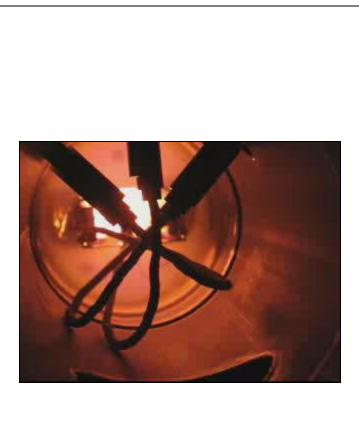
Plasma unstable => run at high pressure (3.5x10⁻¹ mbar) non uniform magnetic field at extremities

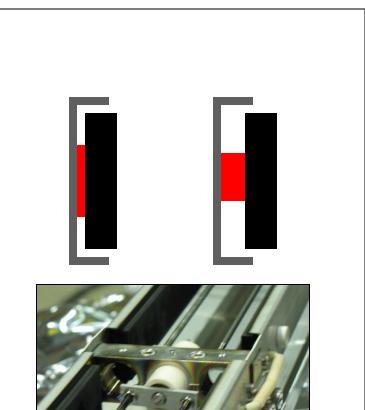
- Plasma unstable => run at high pressure (3.5x10⁻¹ mbar) non uniform magnetic field at extremities
- Ceramic washes for cathode isolation too thin (2 mm) => current leaks => change to ceramic spacers (7 mm)

Highly non uniform transversal thickness profile: ~10x thicker near the cathodes than at the center

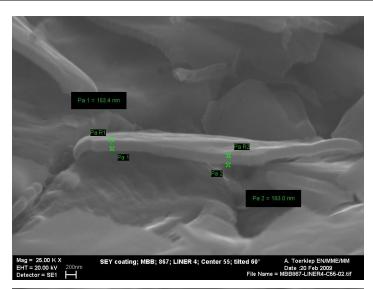
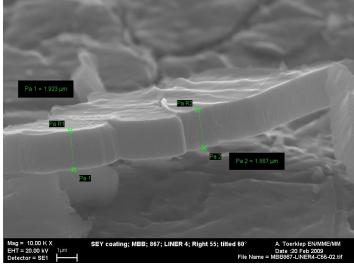
- Plasma unstable => run at high pressure (3.5x10⁻¹ mbar) non uniform magnetic field at extremities
- Ceramic washes for cathode isolation too thin (2 mm) => current leaks => change to ceramic spacers (7 mm)

Highly non uniform transversal thickness profile: ~10x thicker near the cathodes than at the center

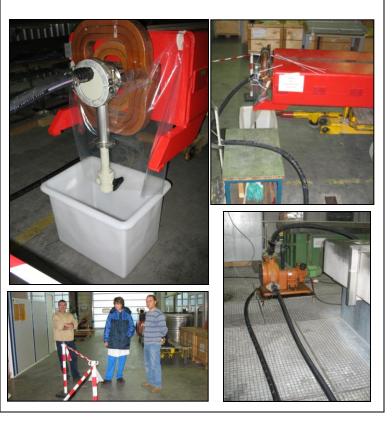
- Control before surface treatment: hydrocarbons and silicon contamination.
- Procedure:
 - 1. Brush with acetone
 - 2. Rinse with demineralized water
 - 3. "lessive" Galvex (for Silicon contaminations)
 - 4. "lessive" P3 Almeco (for hydrocarbons)
 - 5. Rinse with demineralized water
 - 6. Dry by air flow
- Results: ok for silicon; but remain traces of hydrocarbons

"Les résultats ne sont pas brillant, forte présence de particules métalliques et de produit hydrocarbonés (sans surprise). Par contre, présence de produits silicones..."

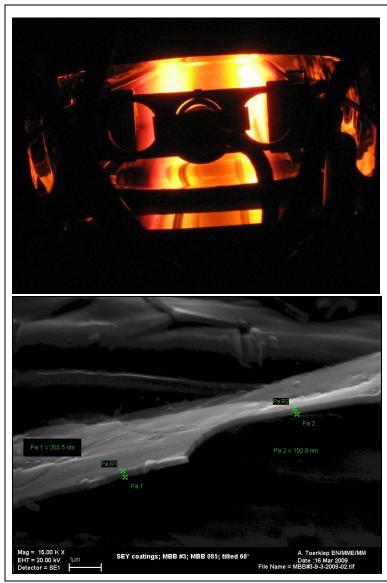
- Thickness: the same non uniformity of the test runs: ~200 nm at the center, ~1500 nm near the cathodes.
- Endoscopy after coating only possible in MB096: no evidence of peel-off .
- Storage after coating: 1.2 bar of N₂
- SEY after coating = 1.0
- SEY just before pump down in the tunnel = 1.0
- During installation in the tunnel <u>PEEL-OFF</u> observed in MB085! (only ~ 1 cm²... but always scaring!)
