SPS-U meeting 2009-03-24

Coating of the three dipoles

SPS dipole prototype coatings Modifications

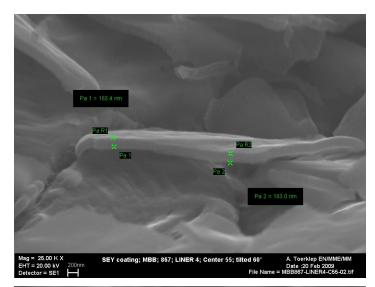
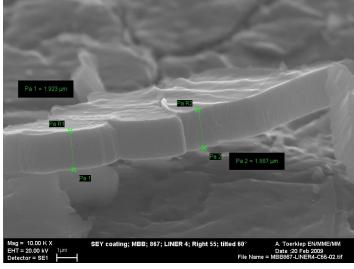
Highly non uniform transversal thickness profile: ~10x thicker near the cathodes than at the center

• During the 4 runs several modifications were introduced. Anodes configuration, isolation, geometry at extremities, thermocouples, etc.

• After the 4th run no more time for tests => COAT DIPOLES
