## Results from samples extracted during SPS shutdown

Diagnostics of the apparent disagreement between the SPS data on coated dipoles and the e-cloud suppression in coated monitors:

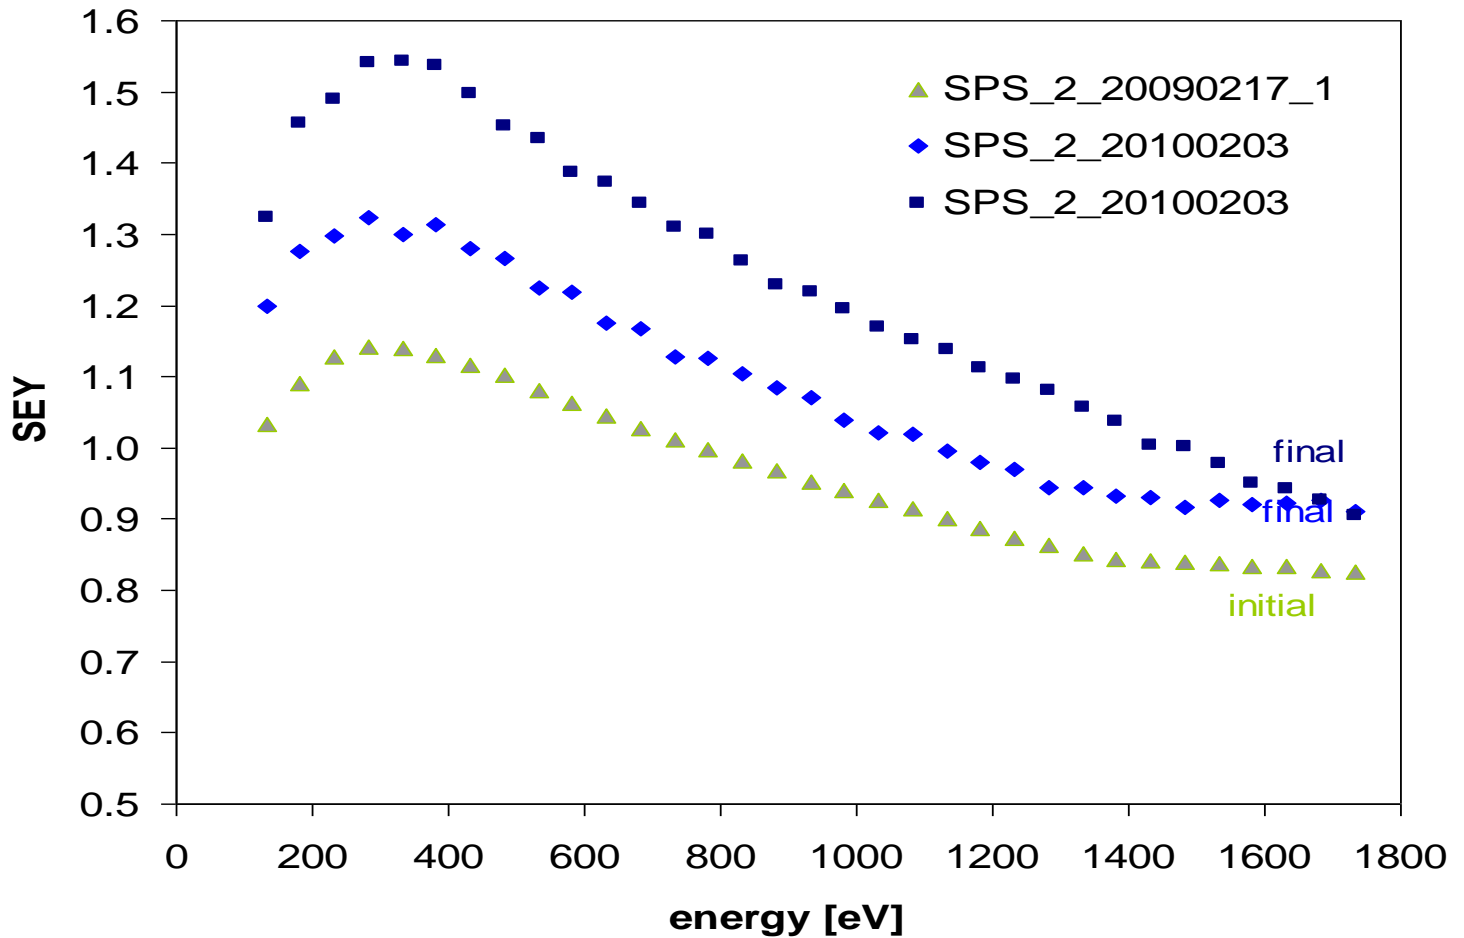
# SEY on removable sample from SPS

History: -coated with same parameters as a liner      May 2008  
          -inserted in SPS:                                      February 2009  
          -vented:    January 2010  
          -extracted:    February 2010
